ROSS ENVIRONMENTAL ASSOCIATES, INC.

RE: *Follow up Indoor Air Screening*
Clegg Residence – Wolcott, Vermont (SMS# 2008-3857)

Indoor Air Screening

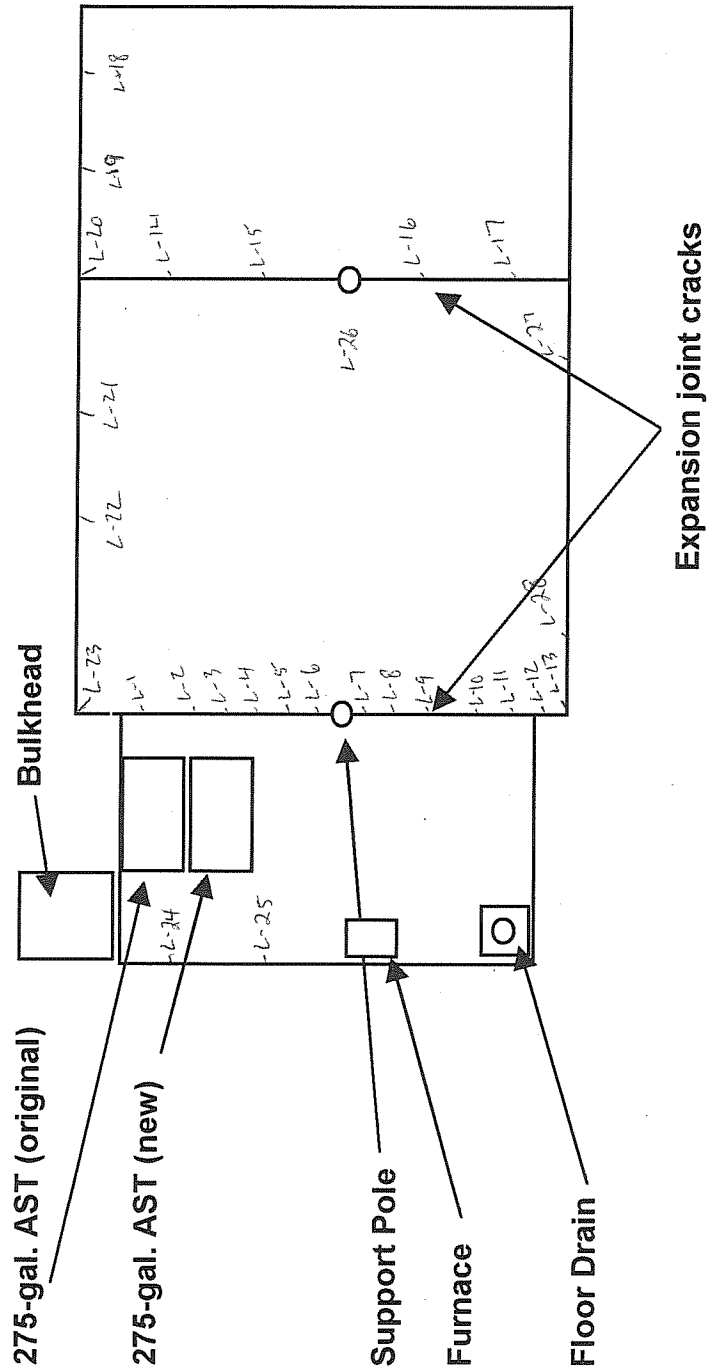
Figure 3
 Indoor Air Screening
 Clegg Residence
 729 Corley Road
 Wolcott, Vermont

- PID readings of the expansion joint crack on the western side of the basement were all 0.0 to 0.1 ppm in all locations north of the support pole.
- PID readings of the expansion joint crack on the western side of the basement in locations south of the support pole ranged from 3.0 to 14.5 ppm. Portions of the epoxy seal material used to seal the expansion joint were noted to be cracked in this specific area.

- PID readings of the expansion joint crack on the eastern side of the basement were all 0.0 ppm.
- PID readings ranging from 0.0 to 18.7 ppm were encountered at the north foundation wall/floor interface.

- PID readings ranging from 19.1 to 28.5 ppm were encountered in a small visible gap at the south foundation wall/floor interface at the southern end of the western expansion joint crack.

Sample ID	PID Reading (ppmv)	Location/comments
L-1	0.0 - 0.1	Expansion joint #1 (north of support pole)
L-2	0.0 - 0.1	Expansion joint #1 (north of support pole)
L-3	0.0 - 0.1	Expansion joint #1 (north of support pole)
L-4	0.0 - 0.1	Expansion joint #1 (north of support pole)
L-5	0.0 - 0.1	Expansion joint #1 (north of support pole)
L-6	0.0 - 0.1	Expansion joint #1 (north of support pole)
L-7	3.0	Expansion joint #1 (south of support pole)
L-8	10.4	Expansion joint #1 (south of support pole)
L-9	14.3	Expansion joint #1 (south of support pole)
L-10	10.9	Expansion joint #1 (south of support pole)
L-11	14.5	Expansion joint #1 (south of support pole)
L-12	28.5	floor wall seam at foundation jog
L-13	19.1	floor wall seam at south foundation wall
L-14	0.0	Expansion joint #2 (north of support pole)
L-15	0.0	Expansion joint #2 (north of support pole)
L-16	0.0	Expansion joint #2 (south of support pole)
L-17	0.0	Expansion joint #2 (south of support pole)

L-18	0.0	floor wall seam at north foundation wall
L-19	0.2	floor wall seam at north foundation wall
L-20	1.9	floor wall seam at north foundation wall
L-21	3.7	floor wall seam at north foundation wall
L-22	18.7	floor wall seam at north foundation wall
L-23	0.7	floor wall seam at north foundation wall
L-24	1.9	floor wall seam at west foundation wall
L-25	1.5	floor wall seam at west foundation wall
L-26	0.1	square hole for former support pole
L-27	0.0	floor wall seam at south foundation wall
L-28	8.7	floor wall seam at south foundation wall
AVERAGE	4.9

However, low concentrations of residual petroleum vapors appear to be diffusing into the basement of the residence by way of preferential pathways not previously observed to be exhibiting elevated PID readings during previous site visits. Observations indicate that the sealing of the main pathways and the seasonal operation of the radiantly heated floor appear to have contributed to the elevated PID readings in the identified areas. Historically, background ambient air PID readings within the basement of the residence have been below 1.0 ppm. No sampling or laboratory analysis of indoor air has been completed at the site. *R.E.A.* recommends completing an evaluation of mitigation options, including but not limited to: resealing of the entire basement floor and/or the installation of a sub-slab depressurization system. The mitigation evaluation may also include an assessment of facilitating an indoor air sampling program at the site.
